**LAND USE PLANNING AND DEVELOPMENT SUITABILITY
IN
QUEENSTOWN, NEW ZEALAND**

A thesis submitted in partial fulfilment of the requirements for the
Degree of Masters of Engineering Geology
at the
University of Canterbury

by
Virginia Cunningham

University of Canterbury
1994

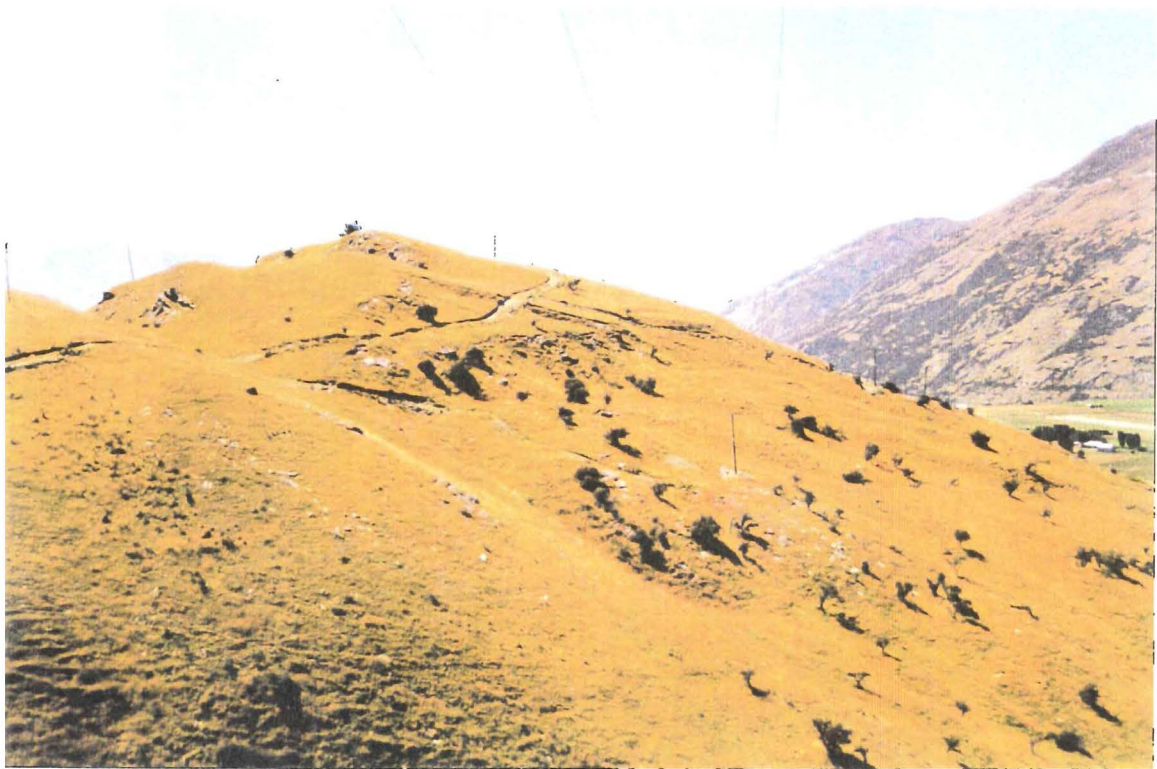
Figure 47: Frankton No. 1 slide. Note the poorly developed head scarp, and the very subdued degraded topography. No evidence of slide mass reactivation following the cutting of the track.

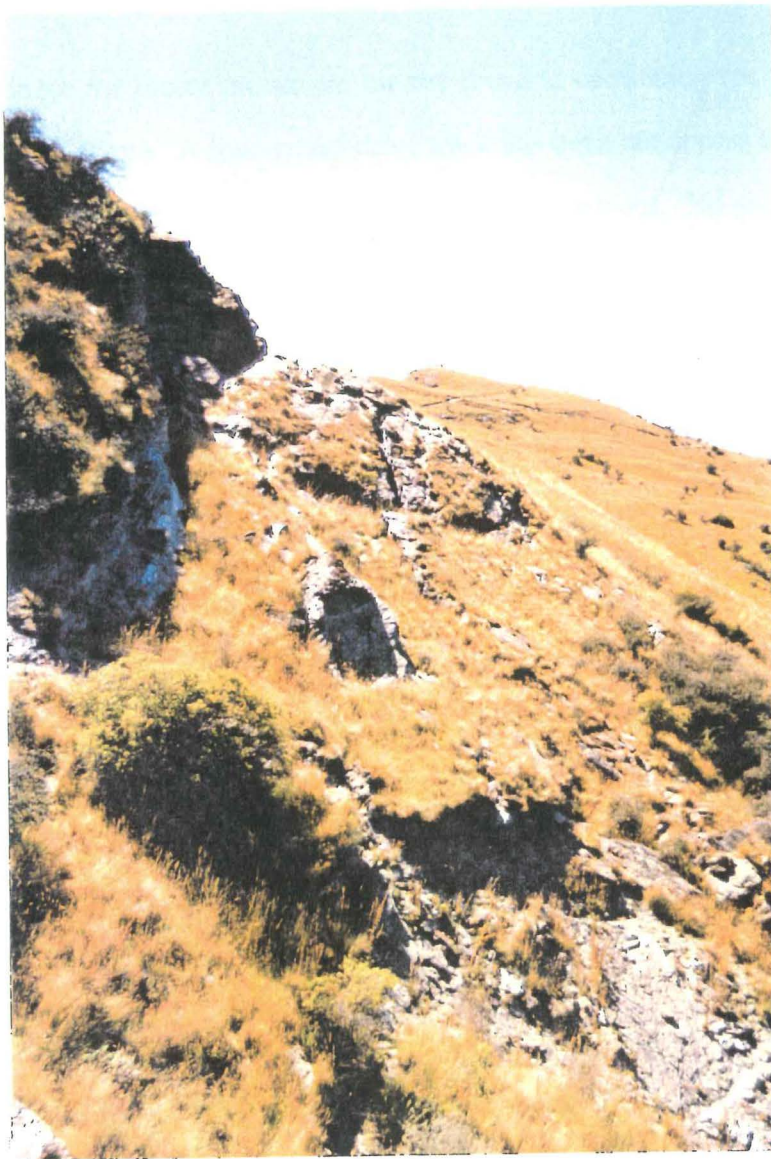
Figure 48: Frankton No. 3 Slide. Note sub-vertical headscarp, the blocky nature of the detached material, and the relaxation and the downslope breakup of the slide blocks.

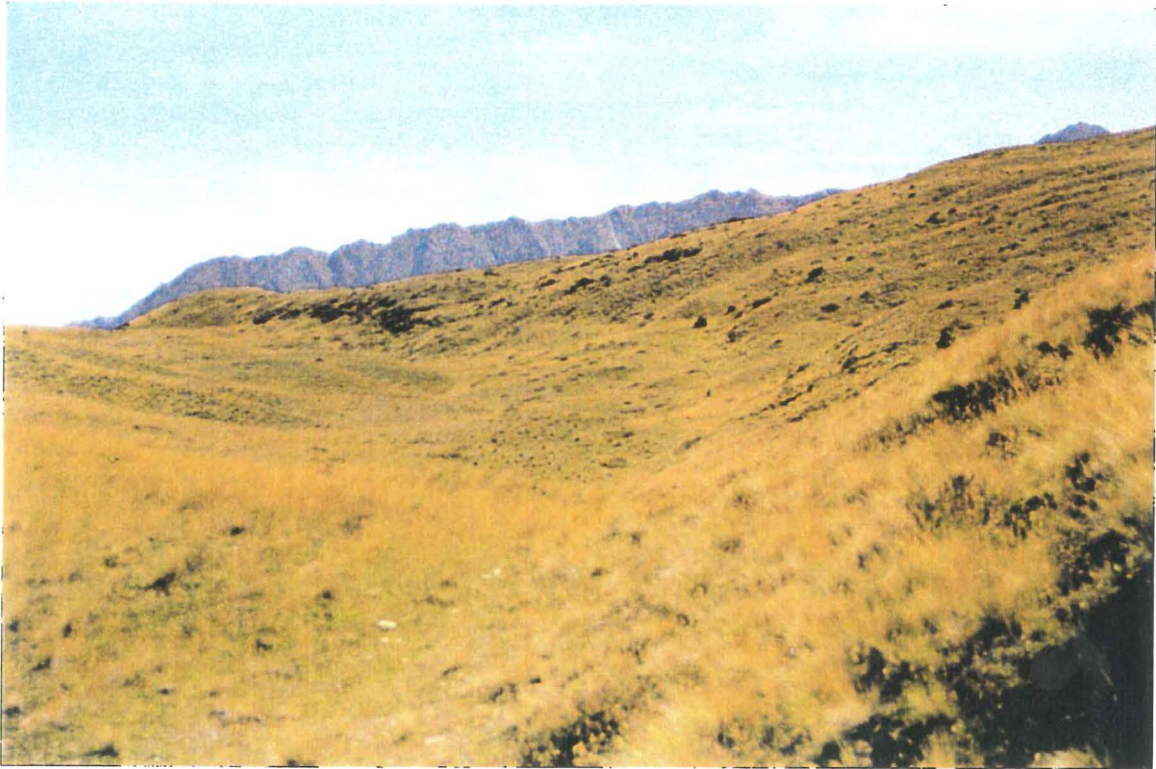
Figure 50: Degraded head scarp (3 to 4m high) of the Queenstown Hill Landslide. View is towards the west.

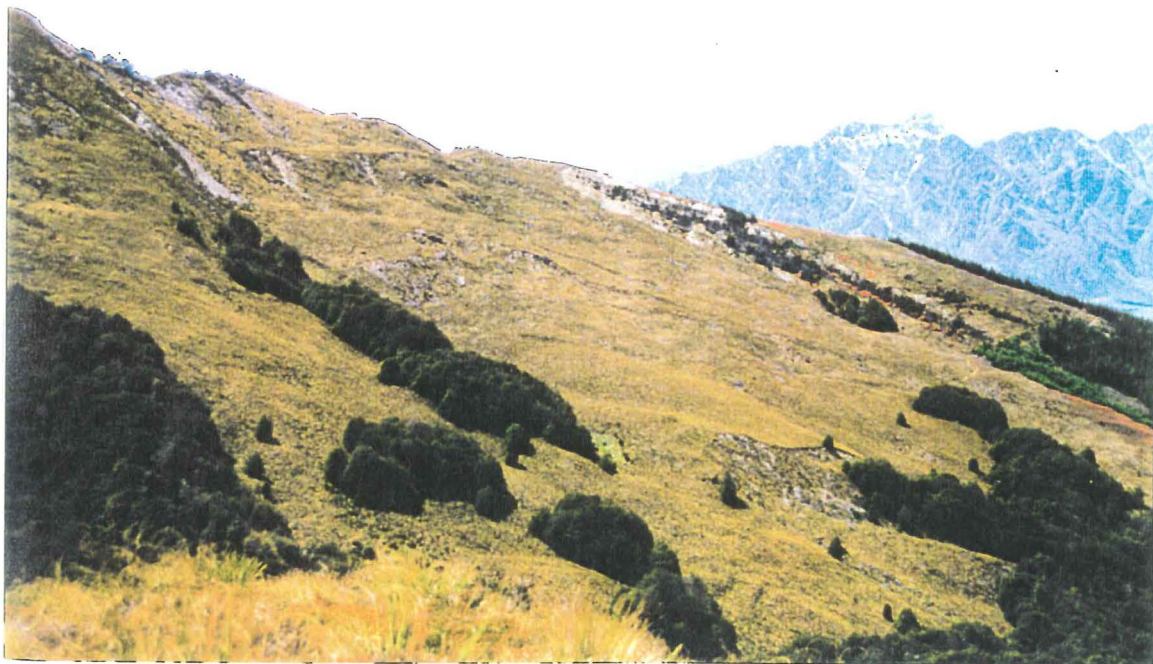
Figure 51: Eastern extent of the One Mile Creek Landslide. Note the prominent east lateral scarp in the distance.

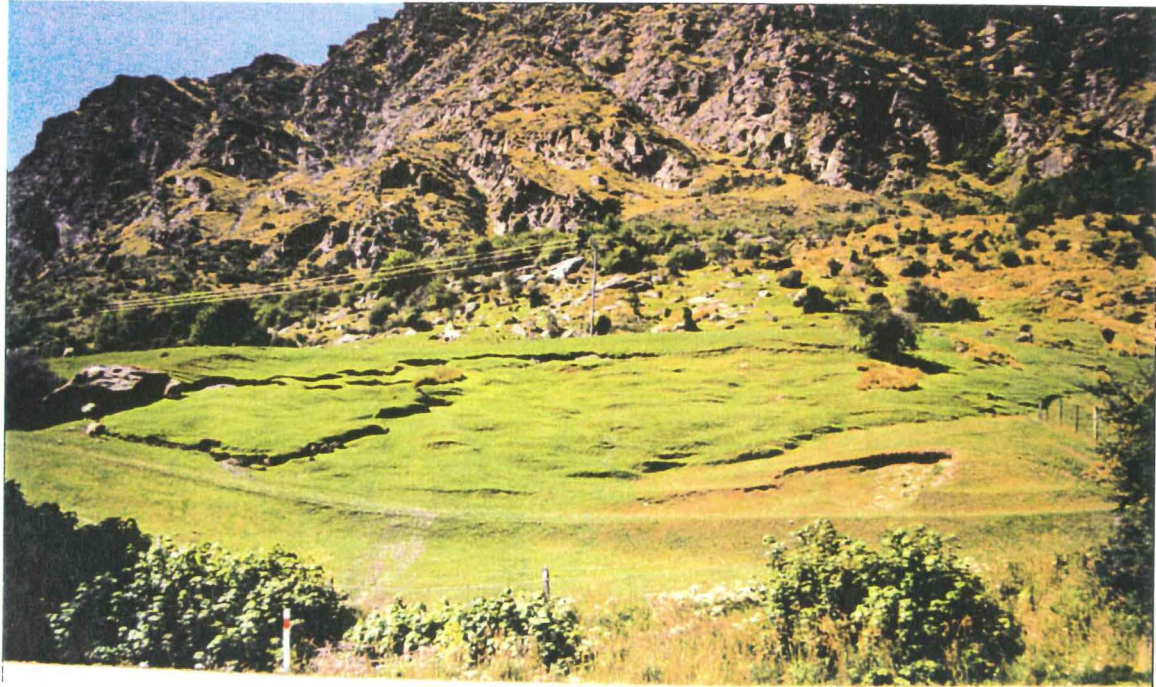
Figure 52: Earthslide in pedological soil following a period of high rainfall, February 1994, Gorge Road. Note the degraded, hummocky slope to the right representing the slide mass of past slope failures.

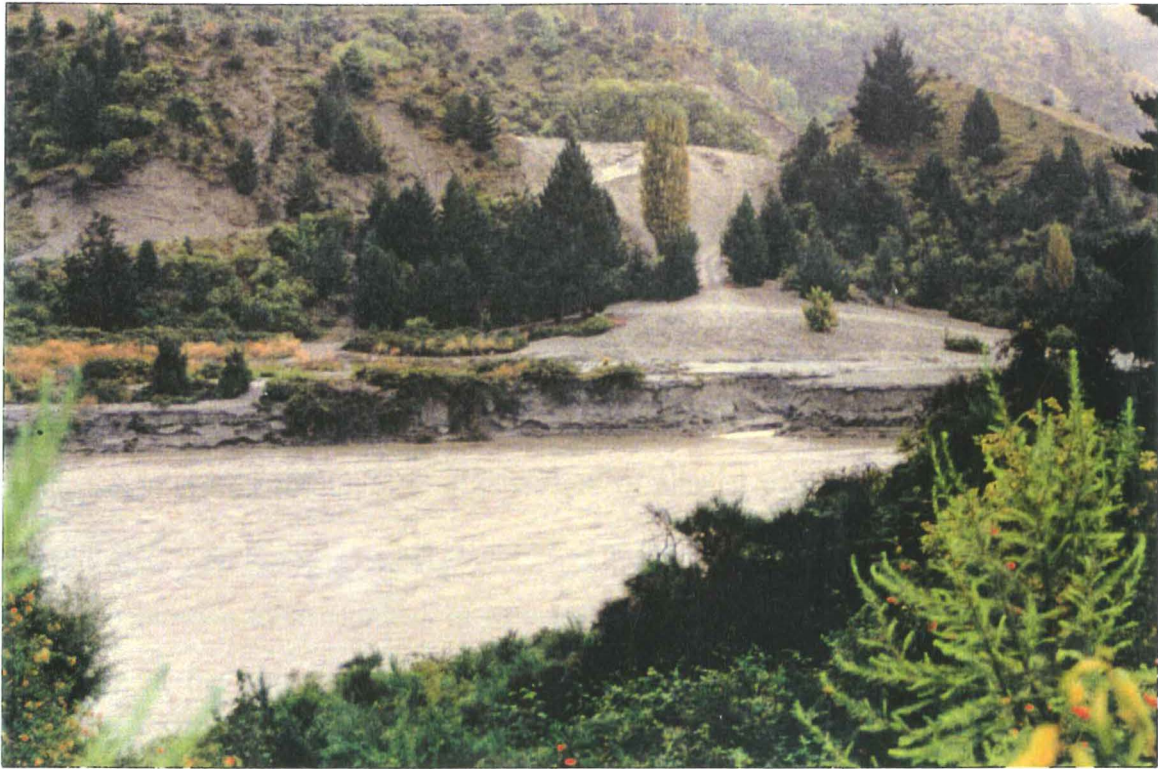
Figure 54: An example of stream-bank erosion (from outside the study area). The Shotover River north of Arthurs Point is progressively eroding the sandy fine gravelly bank. Erosion is particularly accelerated during times of high river flow as was the case in February 1994.

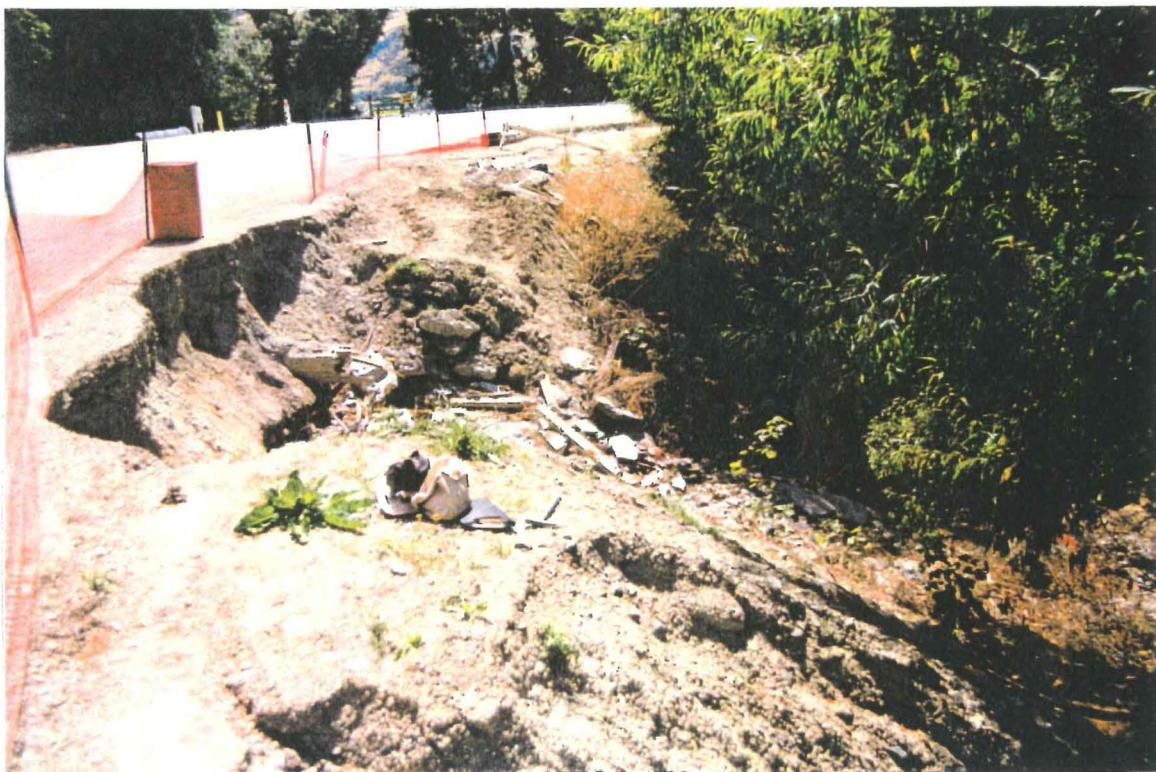
Figure 55: Undercutting of S.H.6 south of the Kawarau Falls Dam following heavy rains February 1994.

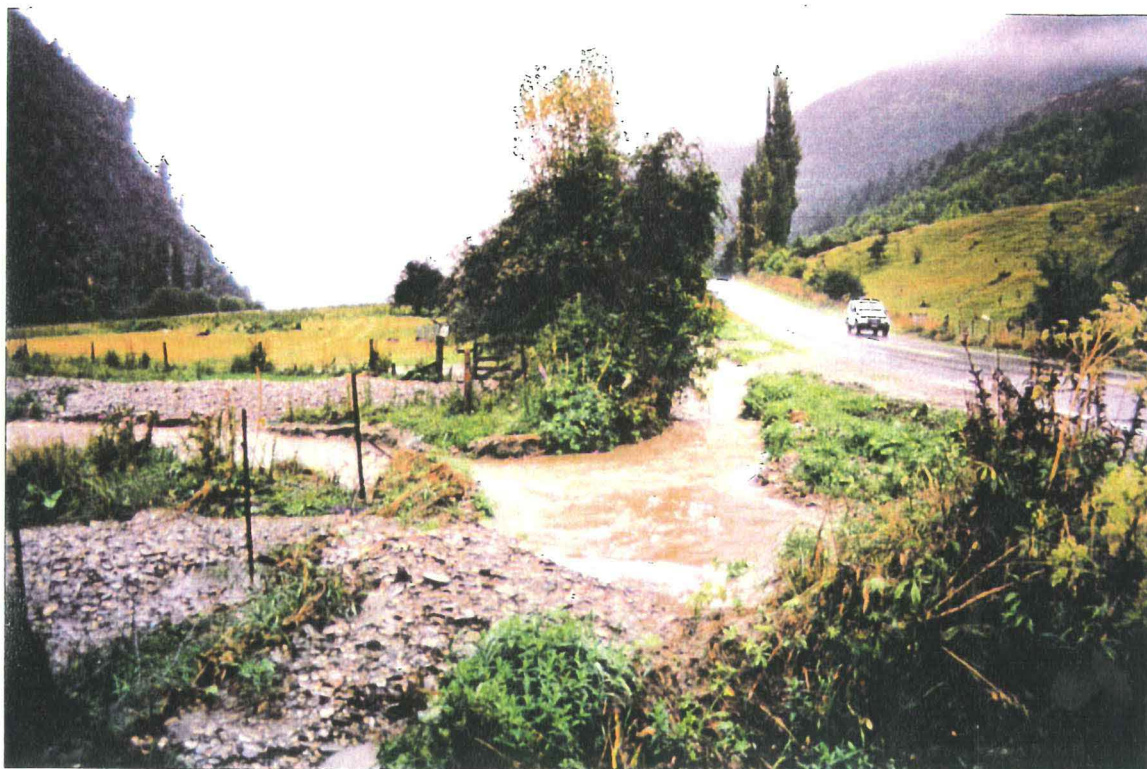
Figure 56: Erosion and debris deposition along Gorge Road following heavy rainfall in February 1994.

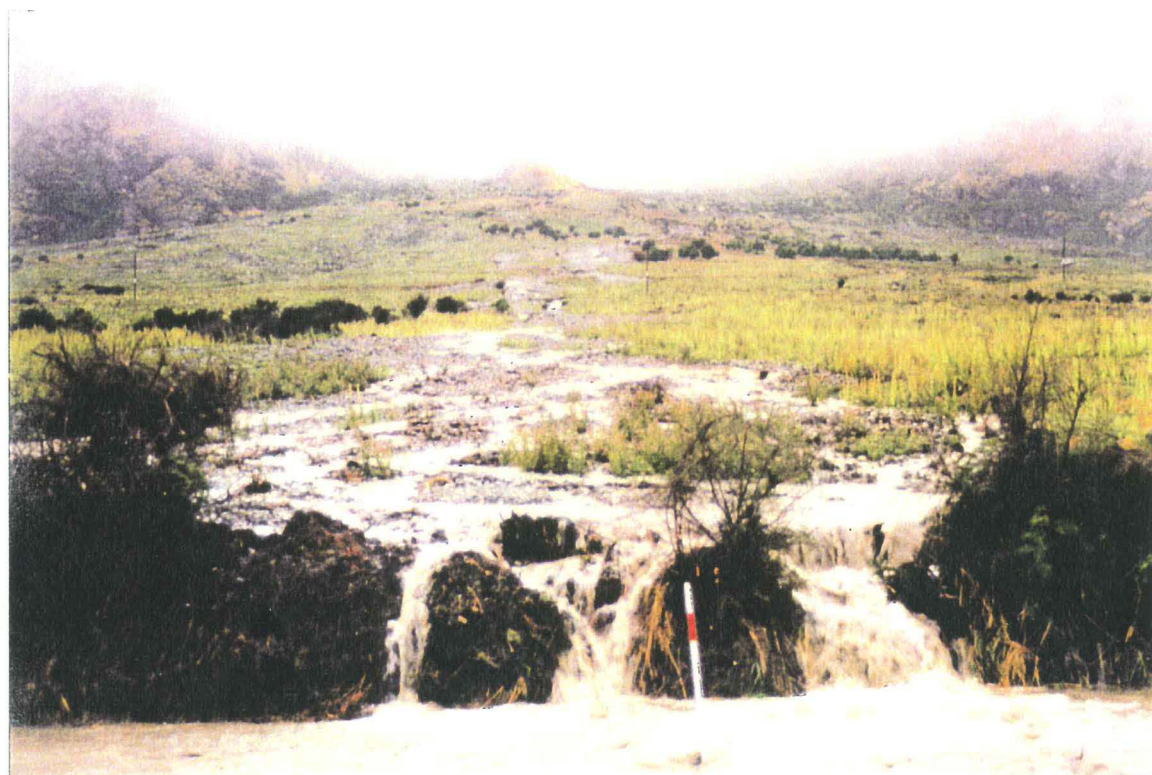
Figure 57: Braided channel migration and debris deposition on fan surface as a result of heavy rainfalls in February 1994, western footslope Remarkables. There was a significant amount of gravel debris deposited on S.H.6 and associated flooding.

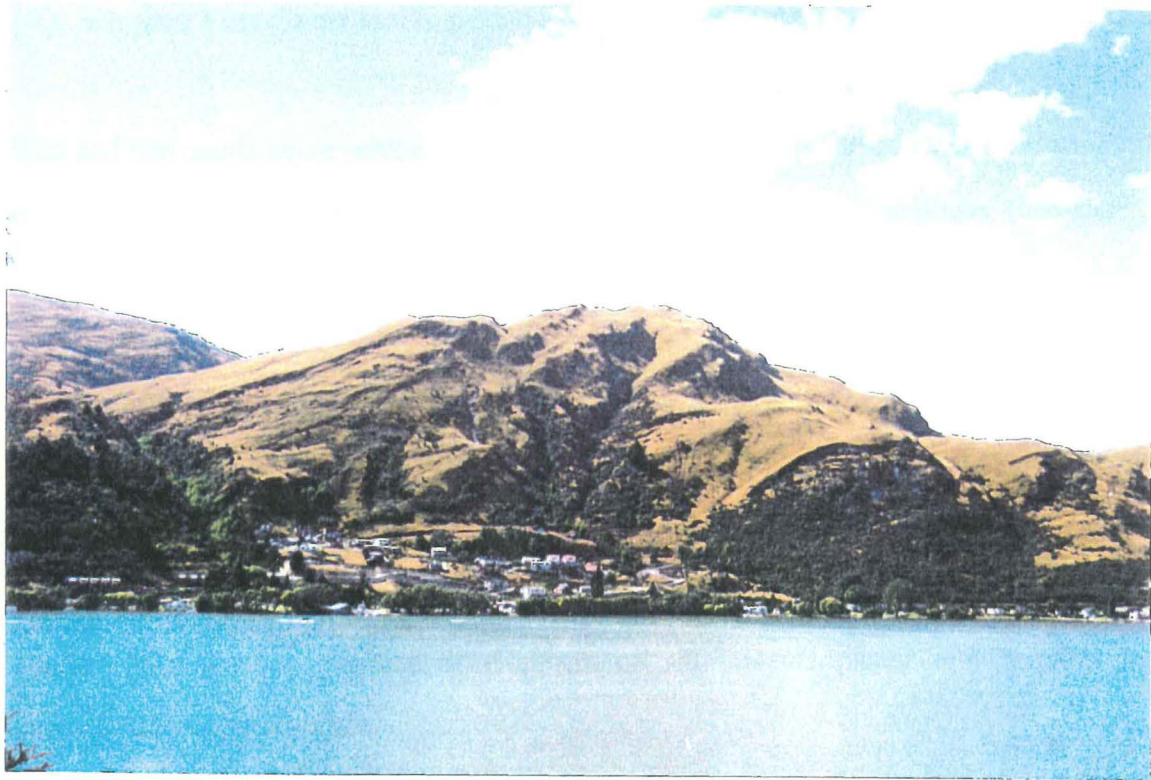
Figure 58: Showing the Marina Heights Slides perched above significant stream channels above a residential area.
